Disaster Resistant University

Preliminary Seismic Screening of University of Nevada, Reno Campus August 2005

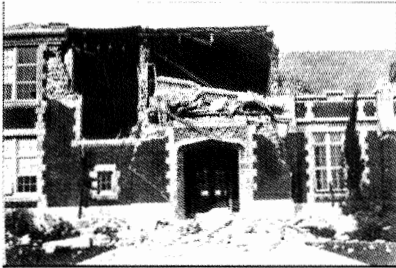
Collapse of School in 1933 Long Beach Earthquake

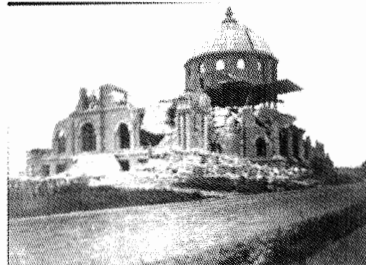
Damage to Library at Stanford University
San Francisco Earthquake on April 18, 1906

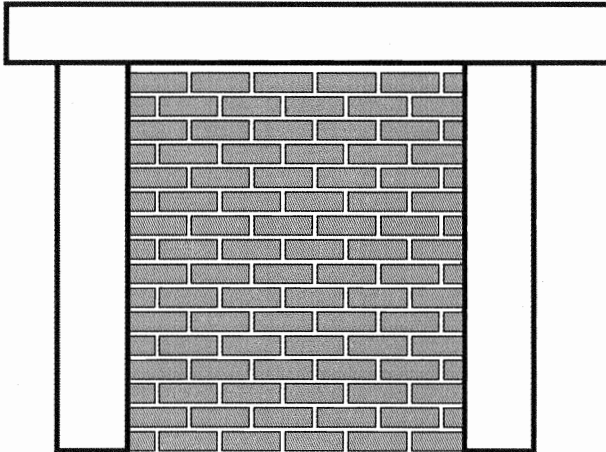
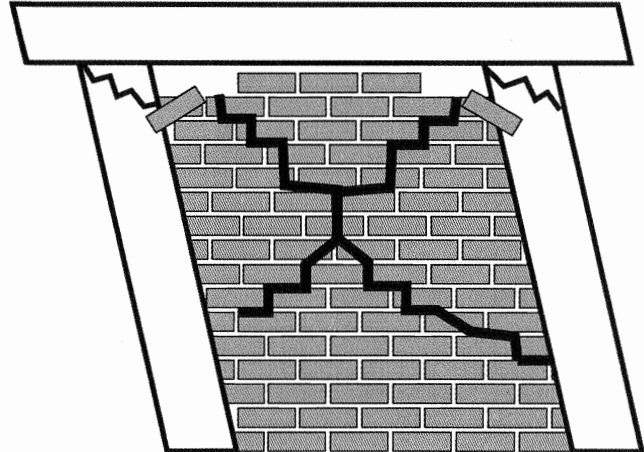
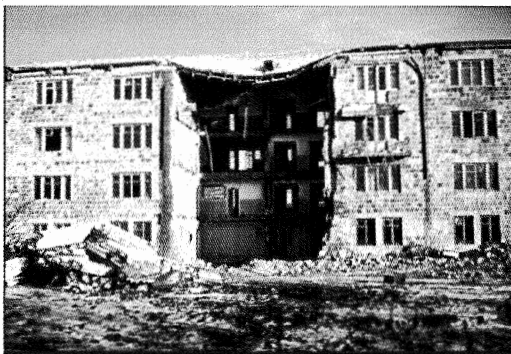
Damage to Concrete-Frame Building, Leninakan, Armenia, December 1988

As earthquake forces make the wall rock back and forth, the wall brings to crack and if the racking is severe enough, bricks will break loose. The example here shows a concrete frame with infill wall. Once the wall begins to degrade, the columns start to break at the top and bottoms due to the earthquake motion that the brick was originally resisting. If the earthquake has enough power and duration, the columns will break completely leading to a collapse.

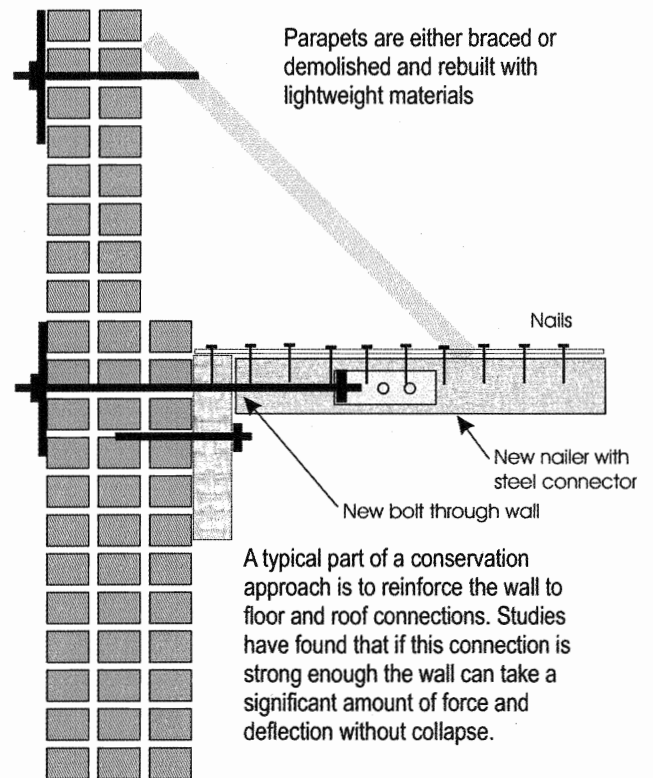
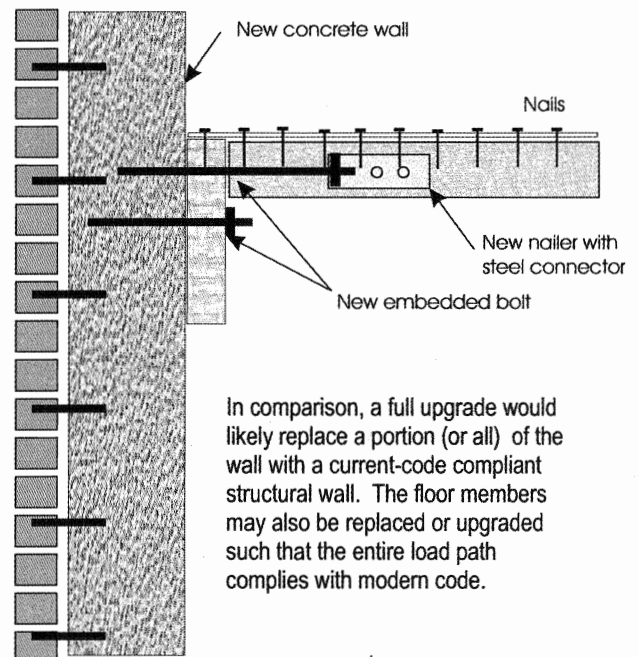
Both conservation and full upgrades are expensive because of the amount of labor required to work within the limitations of an existing building shell

Existing exterior wythe maintained for appearance with new connectors to new structural wall
