Disaster Resistant University

Preliminary Seismic Screening of University of Nevada, Reno Campus August 2005

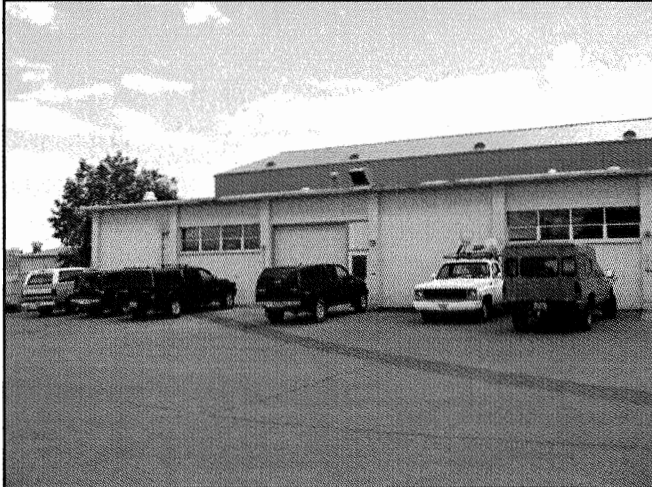
Agricultural Education		AE	
		# 173

Structure Properties and Building Characteristics						
Gravity System	Roof System	Floor System	Floor to Floor (ft)	Total Height (ft)	No. of Stories	Irregularity (Vertical, Plan, Both)
CMU bearing walls; mezz: wood bearing walls	Wood	Main floor: 4" slab on grade; mezzanine floor: wood	Low roof area: max 12; high roof area: max 18.67; mezz: 9.5	Varies, max = 18'-8"	1 + mezzanine level	None

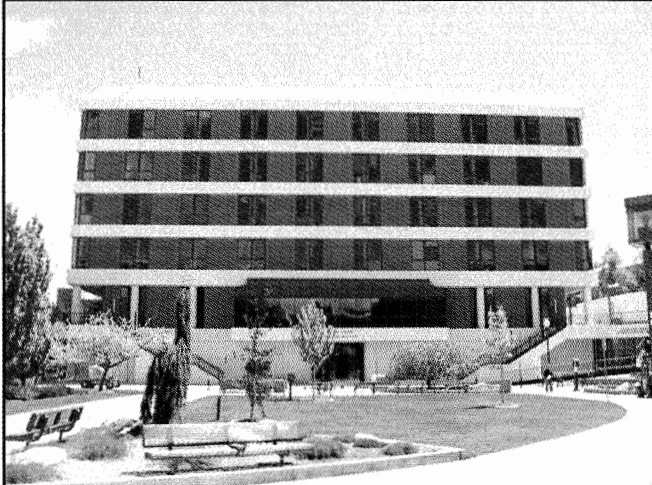
Ansari Business Building		AB	
		# 063

Structure Properties and Building Characteristics						
Gravity System	Roof System	Floor System	Floor to Floor (ft)	Total Height (ft)	No. of Stories	Irregularity (Vertical, Plan, Both)
Concrete columns	Main building: 5" post tensioned concrete slab w/ conc beams	5" post tensioned concrete slab w/ conc beams	16/18/14/14/14/14/5 (parapet)	Total max = 95'	6 + small basement	Vertical

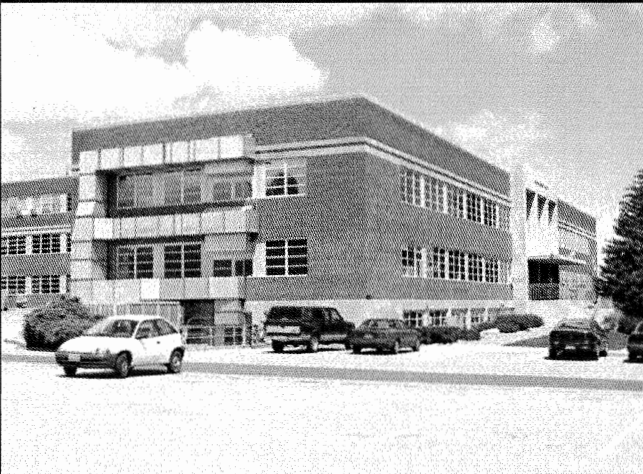
<h1>Applied Research Facility</h1>		ARF	
		# 090

Structure Properties and Building Characteristics						
Gravity System	Roof System	Floor System	Floor to Floor (ft)	Total Height (ft)	No. of Stories	Irregularity (Vertical, Plan, Both)
Concrete walls and columns	Concrete slab (?)	Concrete slab (?)	11.08/11.08/1.08/11.08/13.42	57'-9"	3 + sub basement + basement	Plan

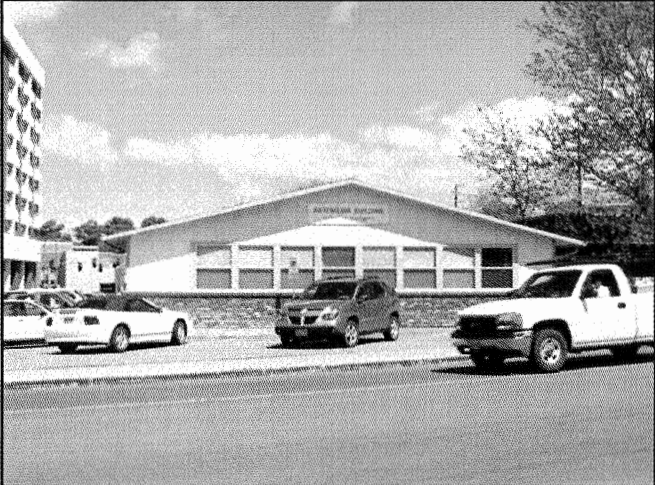
<h1>Artemesia Building</h1>		ARTM	
		# 012

Structure Properties and Building Characteristics						
Gravity System	Roof System	Floor System	Floor to Floor (ft)	Total Height (ft)	No. of Stories	Irregularity (Vertical, Plan, Both)
	Wood	Wood	13.42	Max = ~16'	1	None

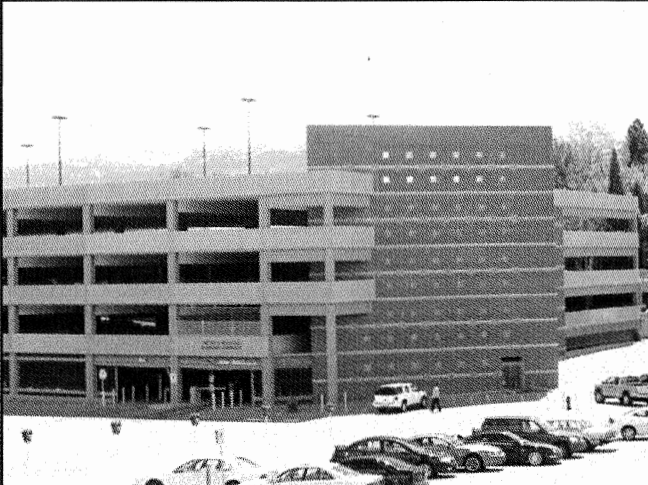
Brian J. Whalen Parking Complex		BWPC	
		# 083

Structure Properties and Building Characteristics						
Gravity System	Roof System	Floor System	Floor to Floor (ft)	Total Height (ft)	No. of Stories	Irregularity (Vertical, Plan, Both)
Concrete columns and concrete bearing walls	6 1/2" post-tensioned concrete slab on post-tensioned beams	6 1/2" post-tensioned concrete slab on post-tensioned beams	11.25/11.25/1.25/1.25	Overall (to top level, not including elevator shaft) = 49'	5	Vertical

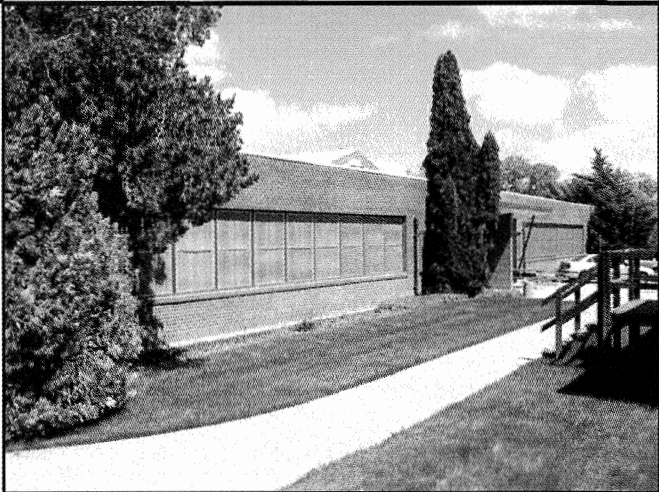
Buildings and Grounds		BG # 076

Structure Properties and Building Characteristics						
Gravity System	Roof System	Floor System	Floor to Floor (ft)	Total Height (ft)	No. of Stories	Irregularity (Vertical, Plan, Both)
Steel for the shops and brick bearing walls for the front portion	?	Concrete slab on grade	N/A	20' +/- max	1	None

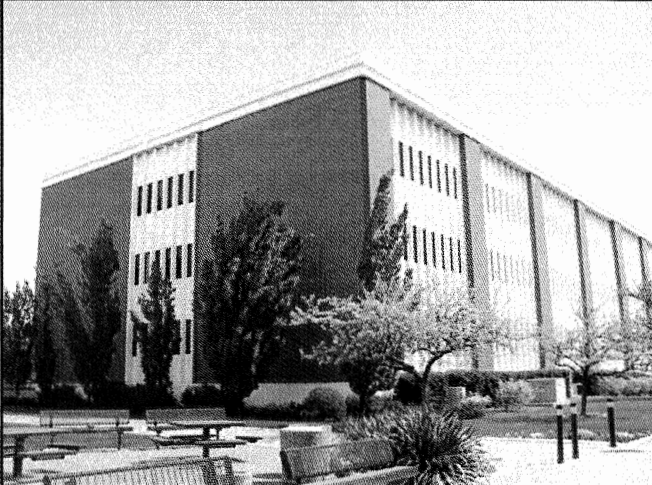
<h1>Chemistry Building</h1>		CB	
		# 071

Structure Properties and Building Characteristics						
Gravity System	Roof System	Floor System	Floor to Floor (ft)	Total Height (ft)	No. of Stories	Irregularity (Vertical, Plan, Both)
Concrete	1" rigid insulation over concrete deck	12" concrete slab	12.5/13.5/13.5/13.5/ varies	69'-9"	3 + basement + penthouse	None

Poor aspect ratio of shear wall in EW direction; vertical is flat slab- 2-way; brick veneer; lateral system: one direction ventilation shafts that are made of 12" concrete walls, with a 4' x 4' opening; other direction is concrete shear wall; architectural precast concrete panels in each direction; repairs done to roof and parapets in 2001 (code 1997)

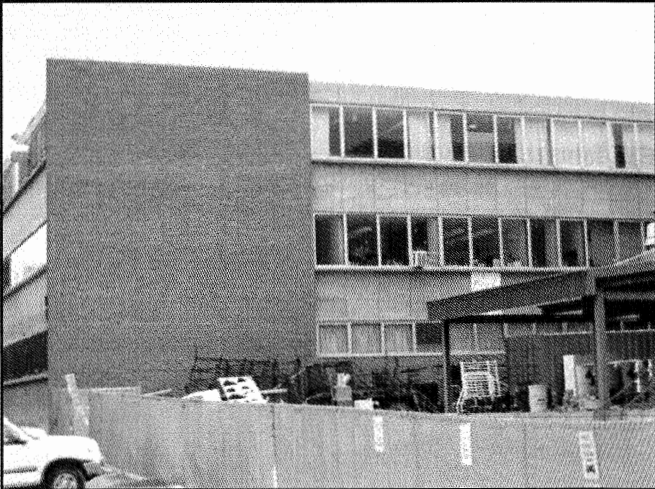
Church Fine Arts- Art and Speech		CFA	
		# 078

Structure Properties and Building Characteristics						
Gravity System	Roof System	Floor System	Floor to Floor (ft)	Total Height (ft)	No. of Stories	Irregularity (Vertical, Plan, Both)
Concrete columns and brick and concrete bearing walls	Pan and joist system	3" concrete fill on metal joist pans	12.5/12.5/12.5 (small section with 8' height- one story)	37'-6"	3	Both

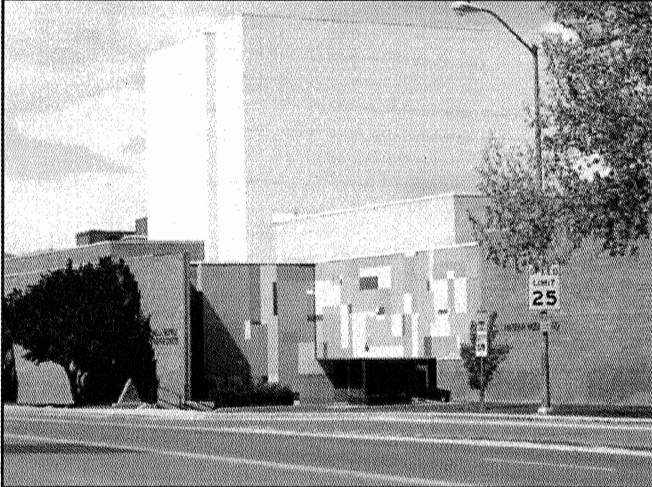
Church Fine Arts- Drama		CFA	
		# 078

Structure Properties and Building Characteristics						
Gravity System	Roof System	Floor System	Floor to Floor (ft)	Total Height (ft)	No. of Stories	Irregularity (Vertical, Plan, Both)
Concrete columns and brick and concrete bearing walls	Steel frame with poured gypsum with 3/4" diameter rod bracing	4" slab on grade	Varies from 20' to 60'	Max = 60'	1	Vertical

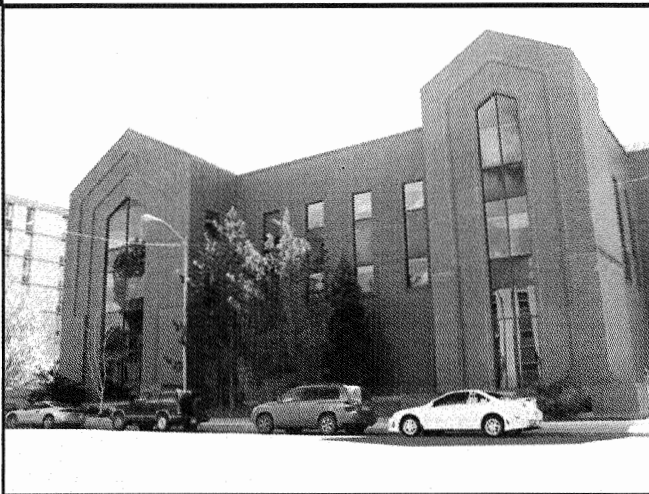
Continuing Education Building (Formerly Midby-Byron Bldg)	CE # 020
--	-------------

Structure Properties and Building Characteristics						
Gravity System	Roof System	Floor System	Floor to Floor (ft)	Total Height (ft)	No. of Stories	Irregularity (Vertical, Plan, Both)
Steel columns	Metal deck (designed with 5 1/2" concrete slab, left out in construction)	6" concrete slab on metal deck	10/14.5/13/13	43'-11" to top of walls (from finished grade)	3 + basement	Plan

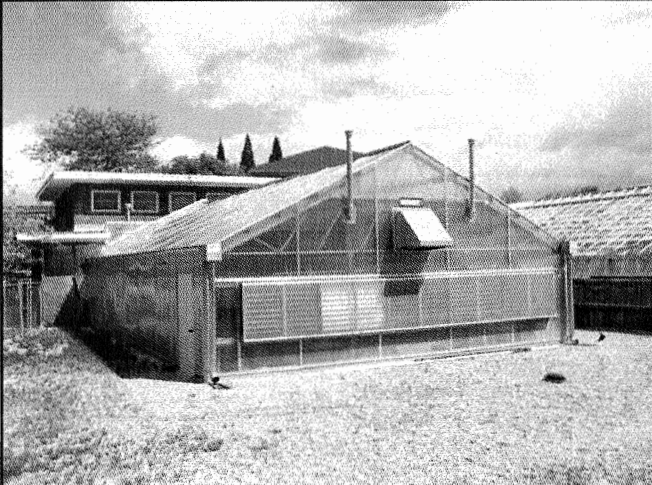
Fleischmann Greenhouses		FG	
		# 045

Architectural plans available - no structural plans; for greenhouses: designed by manufacturer (Lord and Burnham), roof: 1/2 glass and 1/2 aluminum over wood framing, light metal framing.

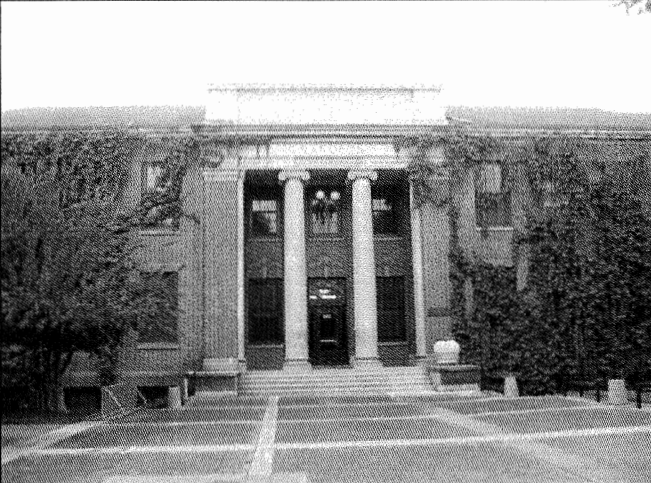
<h1>Frandsen Humanities</h1>		FH	
		# 042

*** 1 point added to final score due to seismic upgrade. No structural plans available; brick shearwall; remodeled in 1999, checked original sheathing and replaced if necessary and provided a new plywood overlay, provided new framing for the 3rd floor (attic) and 2x blocking at plywood edges; added CMU shearwalls in the EW direction at ground level (new wood shear walls extend above); existing URM may contribute to NS lateral system.

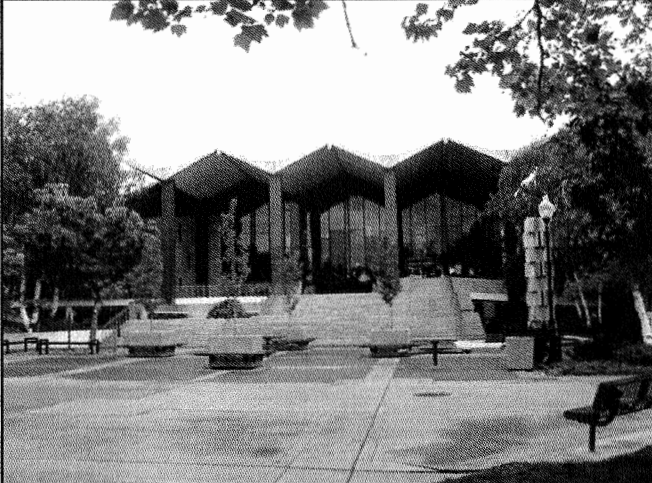
<h1 style="text-align: center;">Getchell Library</h1>		GL	
		# 059

Structure Properties and Building Characteristics						
Gravity System	Roof System	Floor System	Floor to Floor (ft)	Total Height (ft)	No. of Stories	Irregularity (Vertical, Plan, Both)
Concrete bearing walls and columns	Folded plate roof over main building with 4"-6" post-tensioned concrete slab	9" post-tensioned lift slab units (6) with mild steel reinforcing	12/12/9.125	33'-1.5"	3	Plan

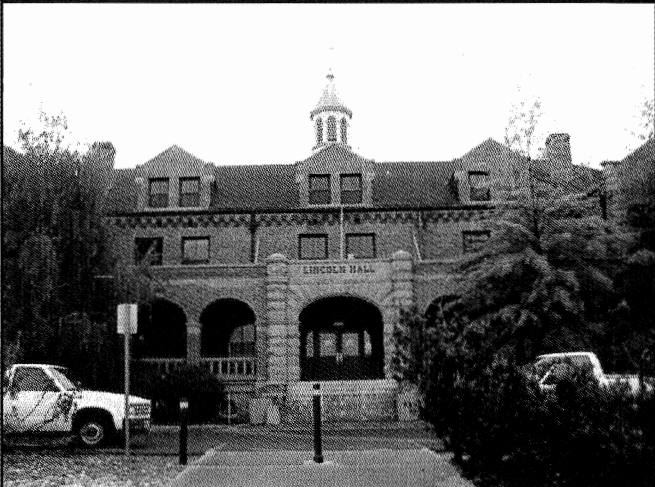
<h1>Lincoln Hall</h1>		LH # 060

Structure Properties and Building Characteristics						
Gravity System	Roof System	Floor System	Floor to Floor (ft)	Total Height (ft)	No. of Stories	Irregularity (Vertical, Plan, Both)
Brick walls					3 + basement
